**Subject:** Stockton School Inspection  
**Location:** 19 S Main St, Stockton, NJ 08559

Statewide Insurance Fund is providing the following loss control inspection report that was conducted for the Stockton School historic building located at 19 S Main St, Stockton, NJ 08559 on June 2nd, 2023. All inspections were conducted to the current PEOSH standards along with loss control safety recommendations.

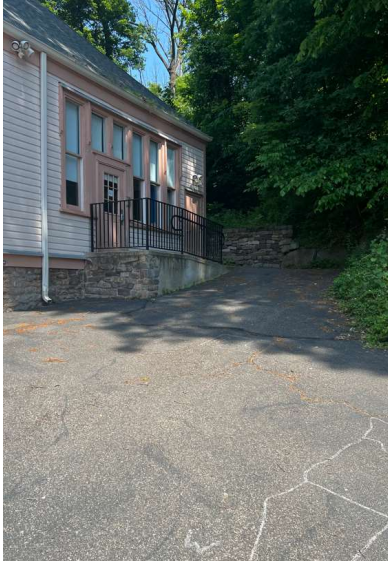
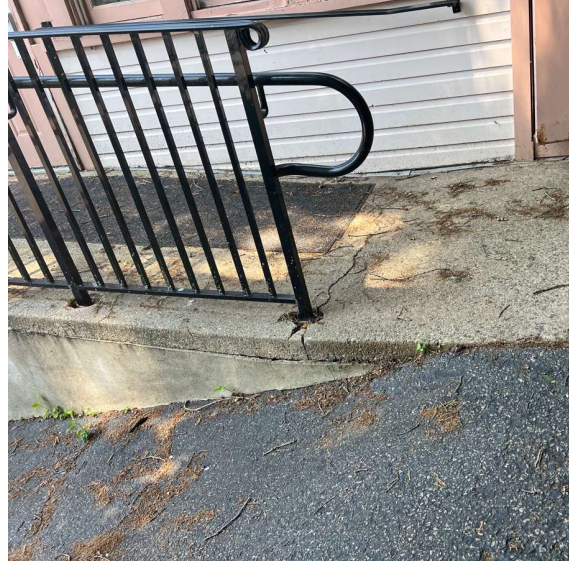
- 1) Ensure the main level access slope meets ADA standards and approved by a qualified engineer:

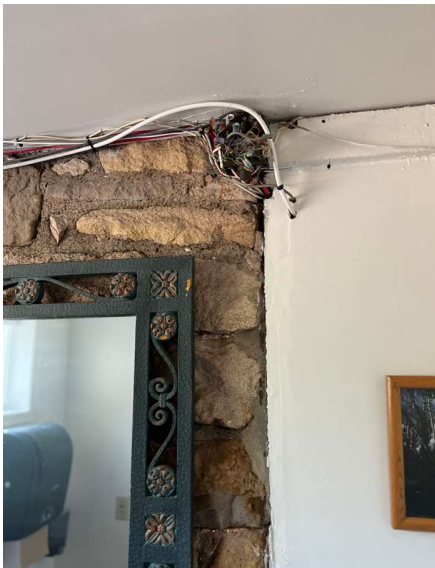
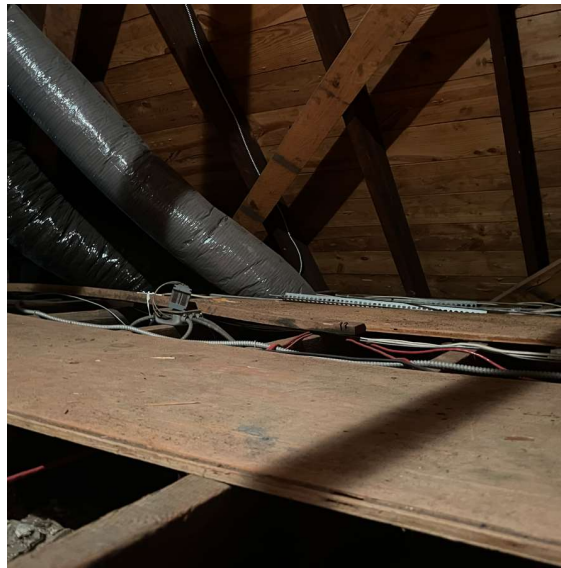
- 2) Ensure all wiring meets current code – exposed wires observed in the basement bathroom and potentially in the limited access attic as well:

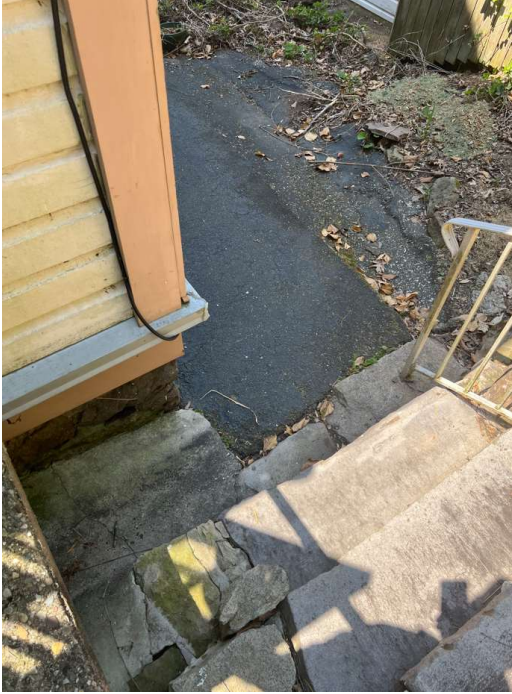
3) Rear access stairs are in need of repair:

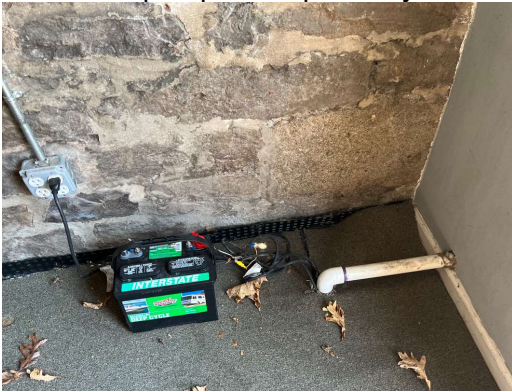
4) Basement pump backup battery needs to be protected.

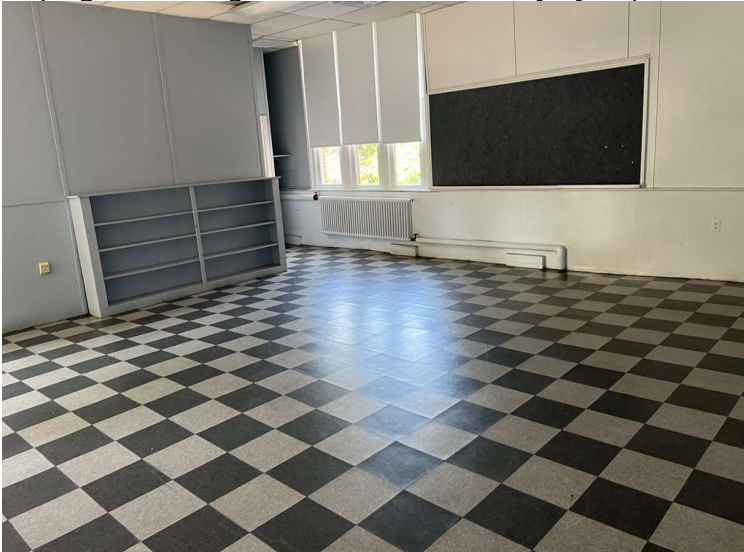
5) On the main level the building has significant floor sloping in all three rooms. Ensure the sloping is not a sign of structural instability by a qualified engineer.

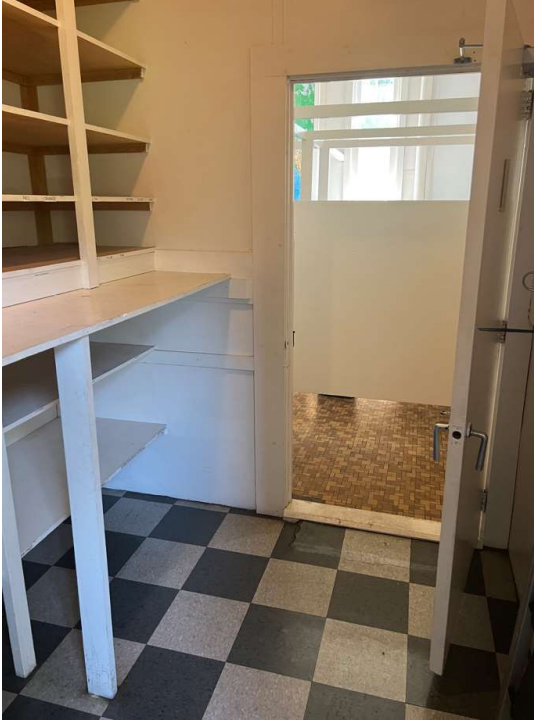
- 6) Confirm aging bathroom facilities will be able to meet ADA compliance:

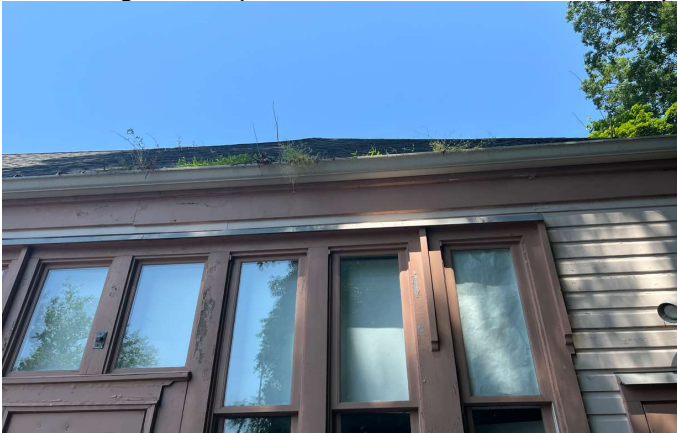
- 7) Significant vegetation growth in gutter may impact roof and cause water damage. Both a roof and gutter inspection are recommended by a qualified engineer:

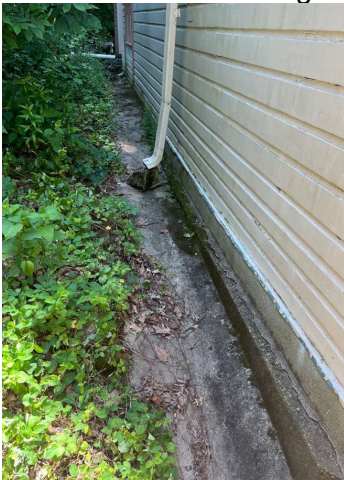
- 8) The rear of the building has a facing slope that could lead to water damage during a storm – rainwater runoff and gutter drainage should be examined by a qualified engineer:

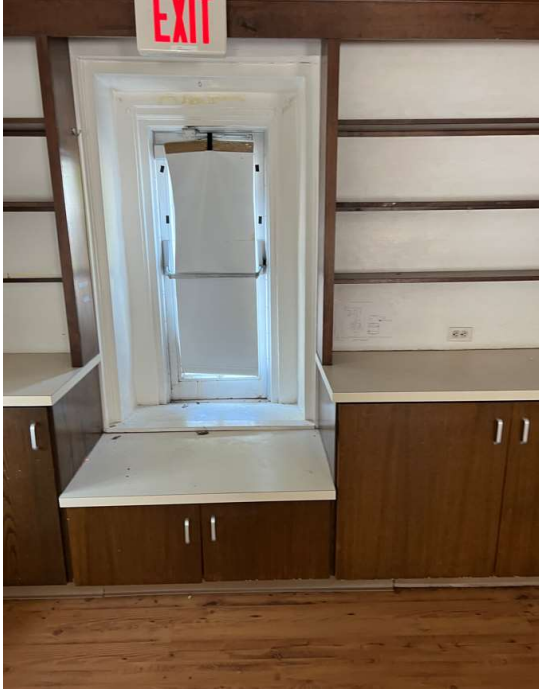
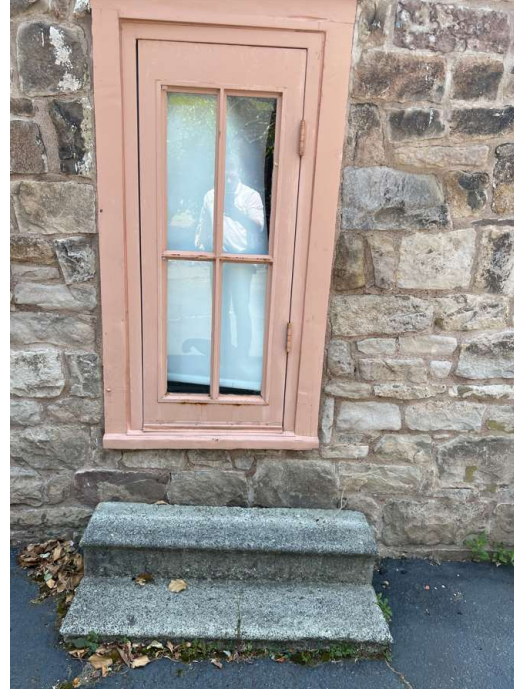
9) Confirm basement emergency exit is in compliance with current fire evacuation standards:
