**PHASE I ENVIRONMENTAL SITE ASSESSMENT/
PRELIMINARY ASSESSMENT
FOR
19 SOUTH MAIN STREET
BLOCK 7, LOT 27
BOROUGH OF STOCKTON
HUNTERDON COUNTY, NEW JERSEY**

May 4, 2023

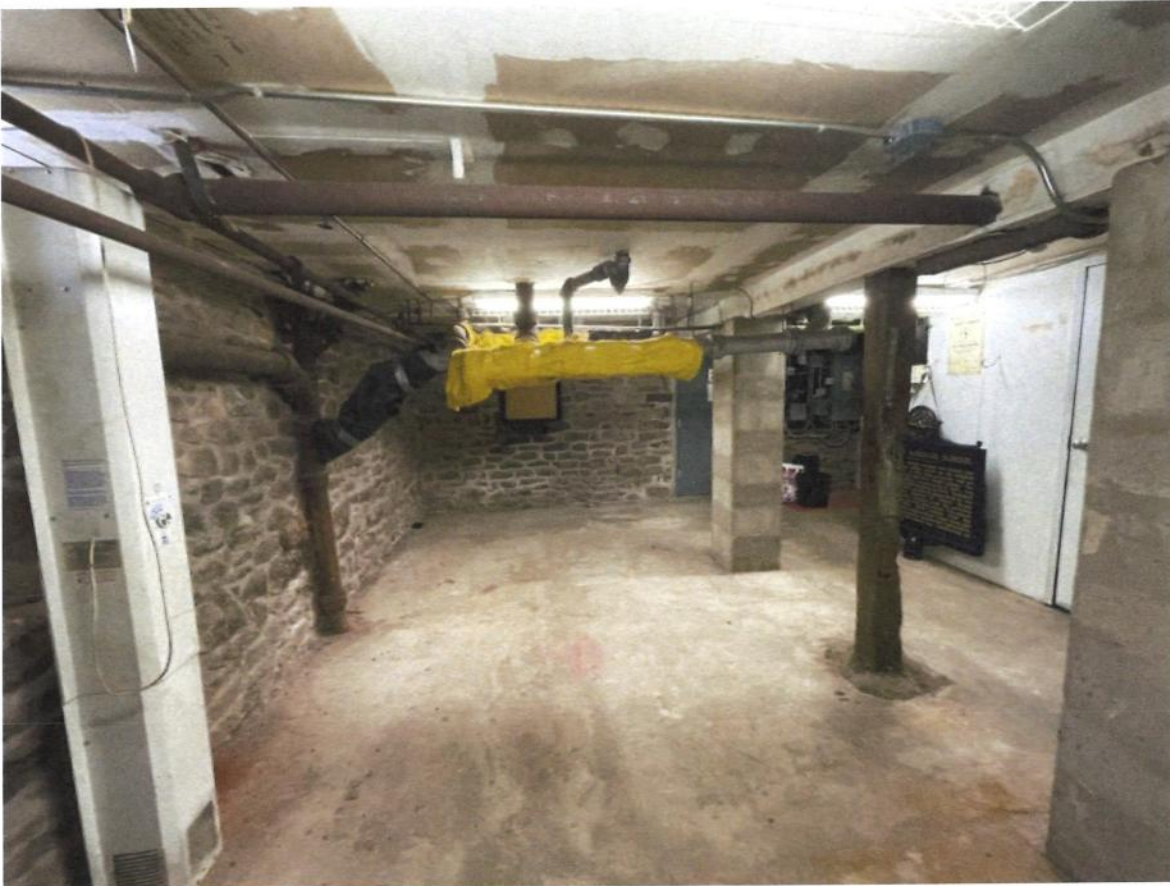
A floor drain was observed in the basement of the building. There was no apparent staining on the concrete floor around the drain, which reportedly discharges to the municipal sewer system. *No further investigation of AOC-3 is warranted.*

7. Representative view of the basement.

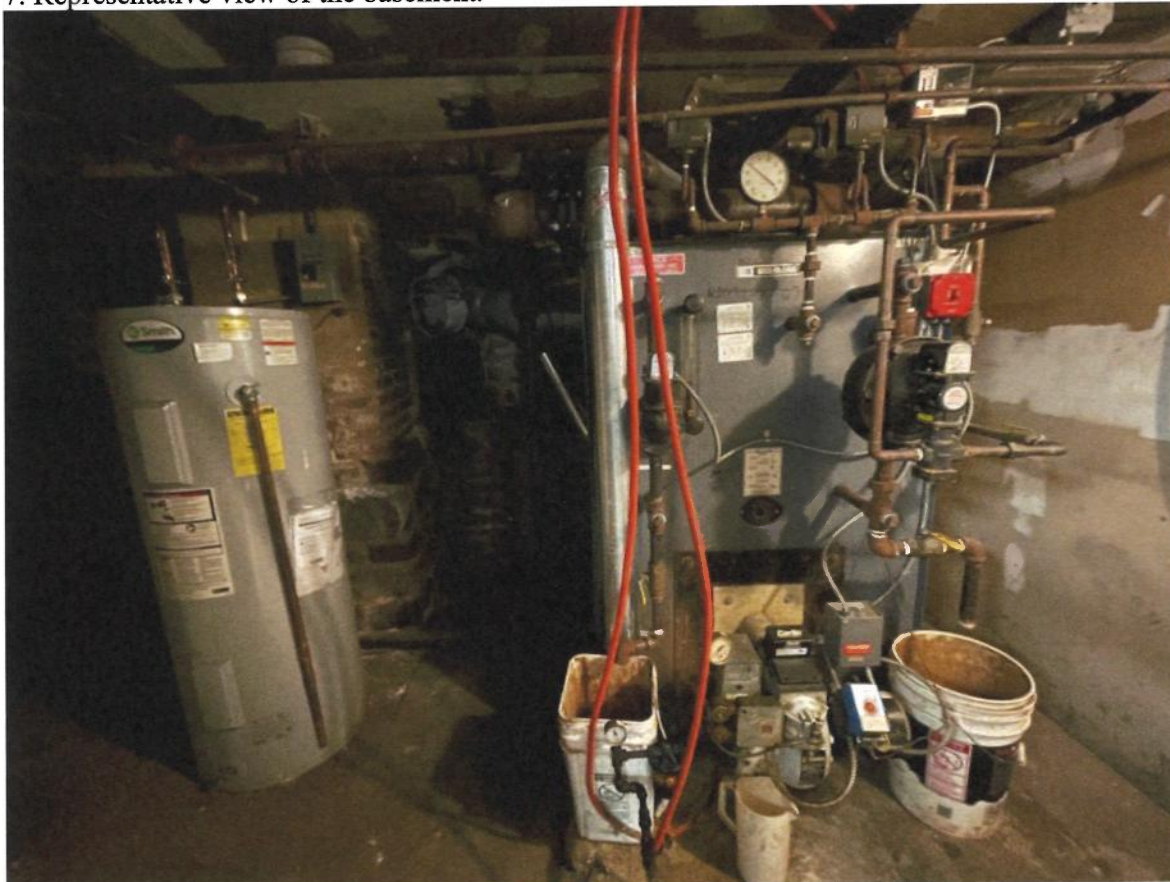
- **Heating and Cooling** – The Site is currently heated by a combination of natural gas utilities provided by Elizabethtown Gas, and No. 2 heating oil stored in a 275-gallon aboveground storage tank (AST). According to Mr. Gallagher, the building was reportedly heated by No. 2 heating oil for several decades, although the building reportedly utilized a coal furnace prior to that time. An inactive coal chute was observed in the basement of the building. The building is cooled via central air conditioning.

8. Representative view of the boiler room.

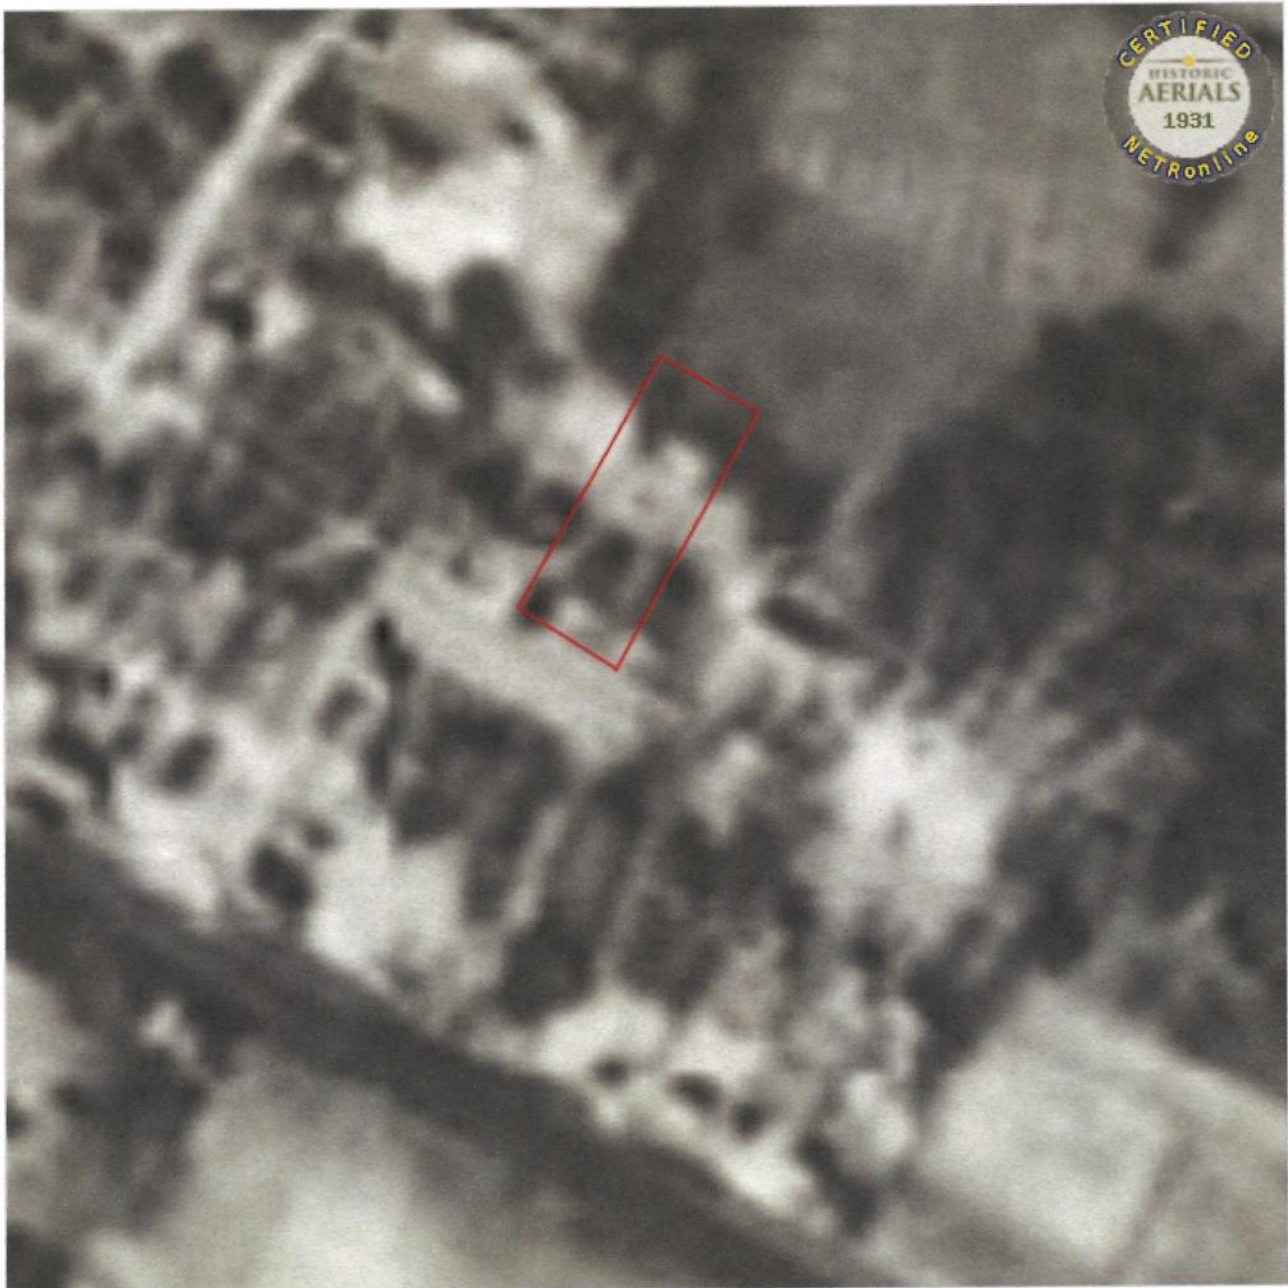
- **1931 Aerial Photographs** – This aerial photograph showed the Site developed with what appeared to be the present-day building, although due to poor photograph clarity, specific features on the Site and surrounding properties could not be distinguished, although South Main Street was apparent to the south.
- **1940 through 2019 Aerial Photographs** – These aerial photographs showed the Site developed with the present-day school building in a similar configuration as today. The surrounding land appeared similar to present-day conditions consisting of vacant woodland to the north, South Main Street to the south, a church to the east and a residence to the west. South Main Street was apparent to the south.

1931 aerial photograph
